Non Destructive Testing of Drystone Walls

Warren, Laura

Awarding institution:
University of Bath

May 2018

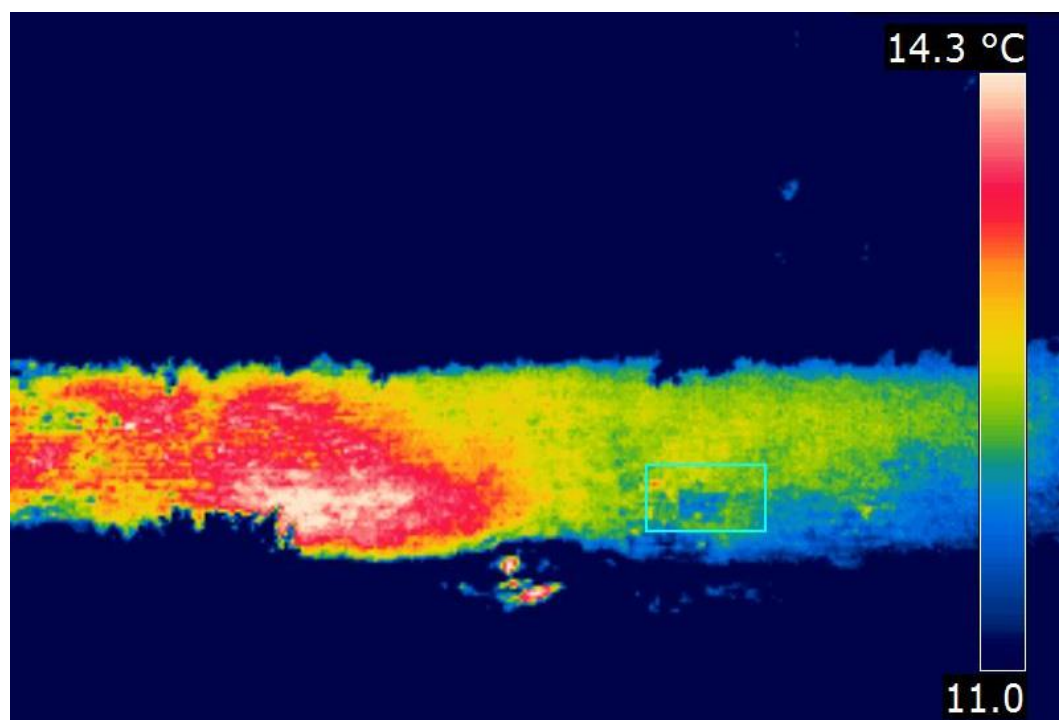
Image taken: 22:00 06/06/13; main temperature difference between mortared and non-mortared area as above. Cooler area (highlighted) looks to correspond to an area of weathered stone.

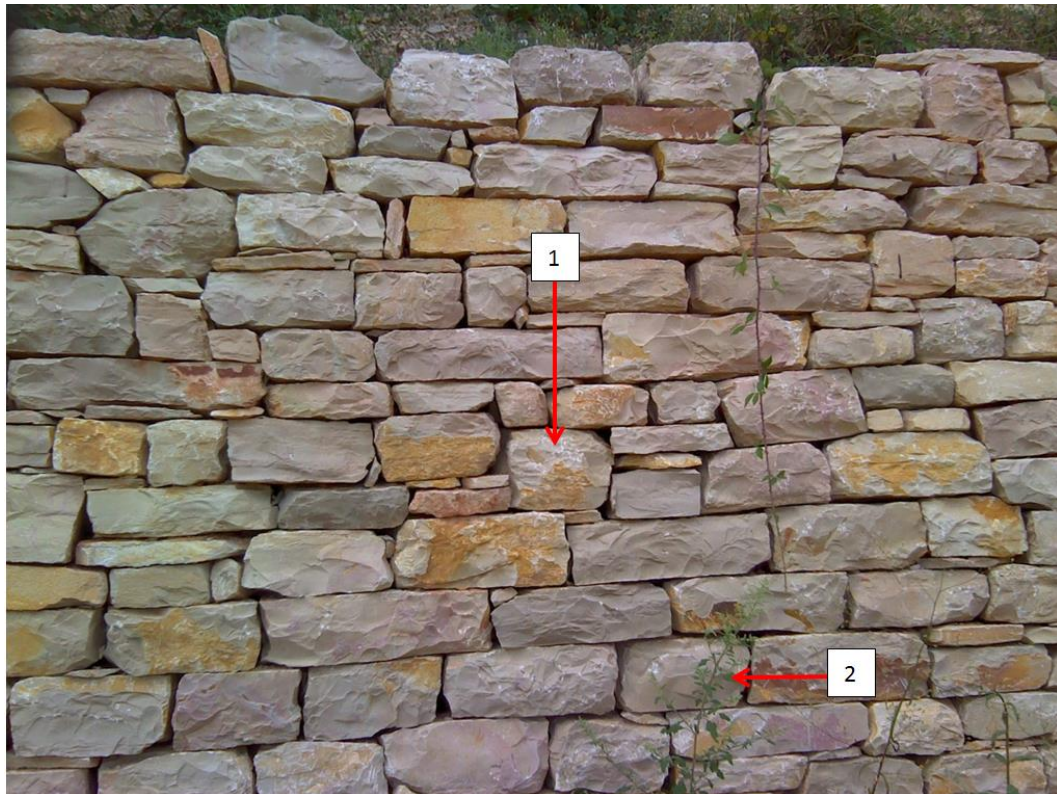
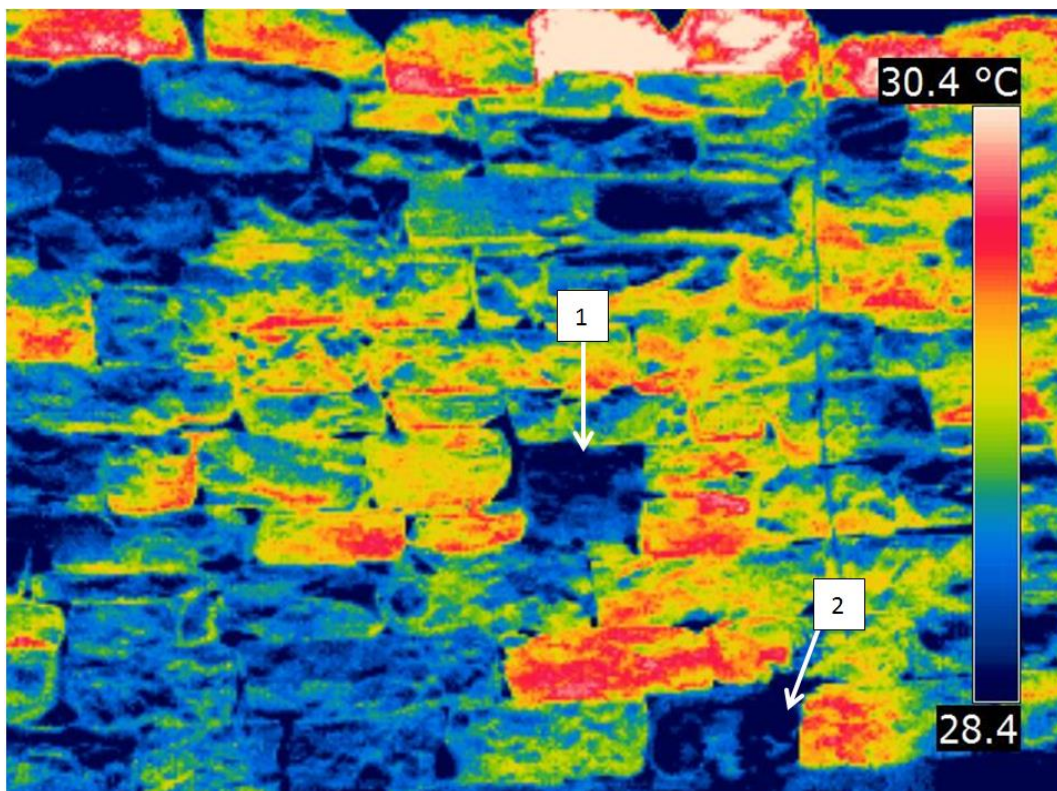
East facing Wall at the Monastery, St Enimie, France Approximately 1.25m high. Taken 14:10 06/09/13. Stones 1 and 2 can be seen to be cooler than those around then suggesting better contact to the backfill.

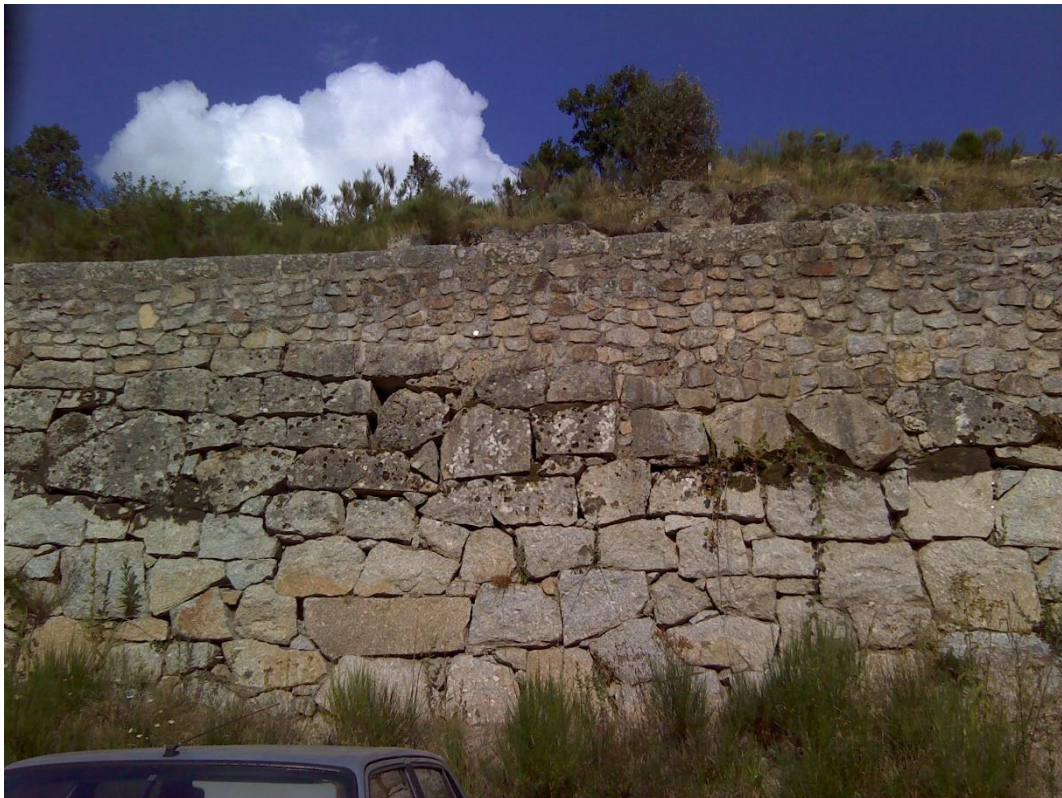
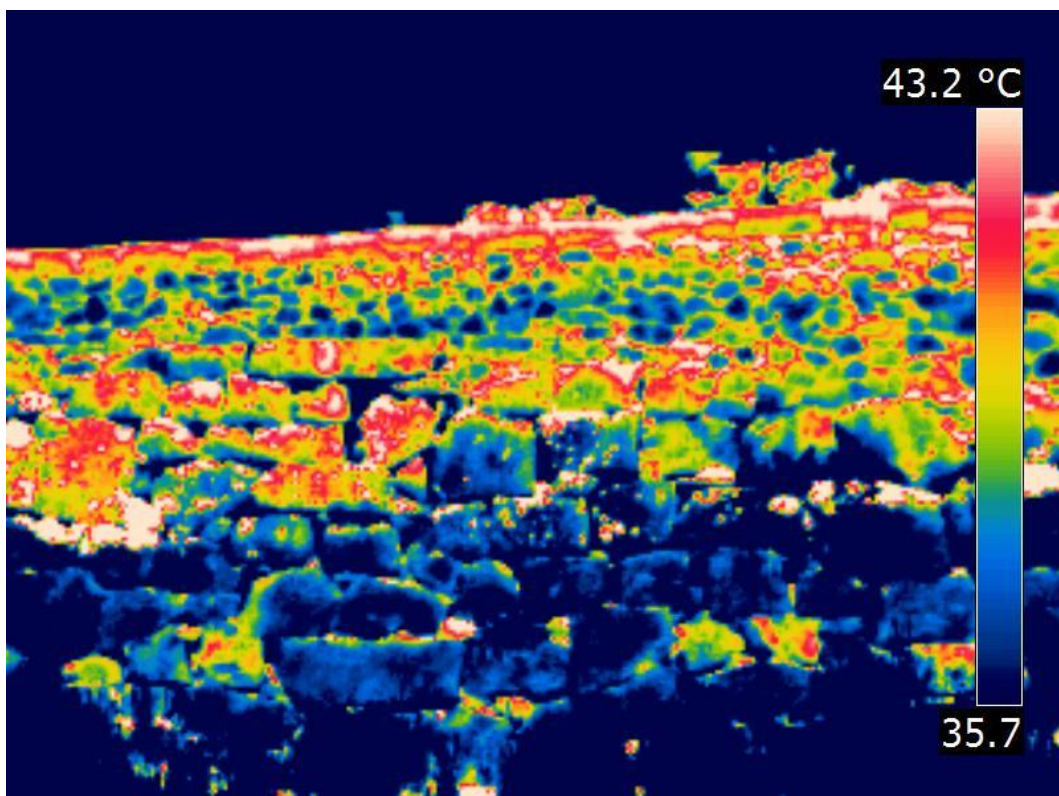
South Facing Historic Wall, Pont du Monvert, supporting the D998, France. Taken 15:30 06/09/13. When this image was taken the wall was in full sun and shows the temperature fluctuation across the surface of the stone as seen in Figure 7.19 (Ffestiniog Railway). When imaged in the morning (below), more uniform temperatures across the stone surfaces were seen.

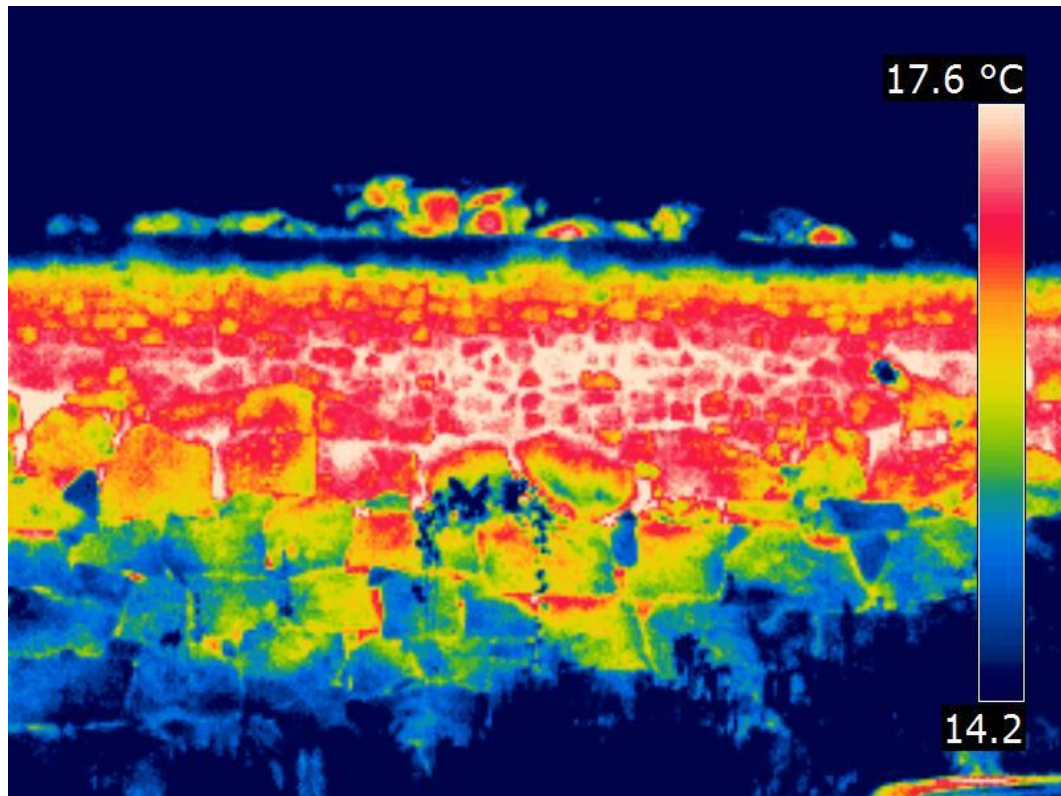
Historic Wall, Pont du Monvert. Taken 08:00 07/09/13. More uniform temperatures across individual stone faces seen at this time. The top section of the wall is a mortared parapet to the road and can easily be identified in the image.

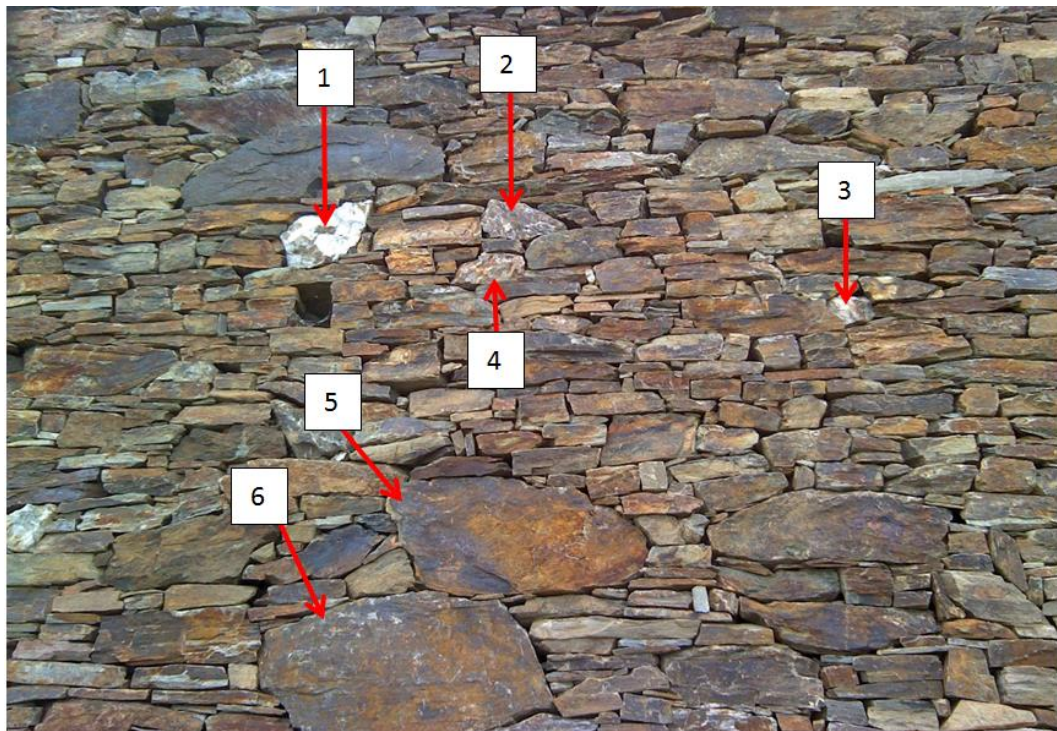
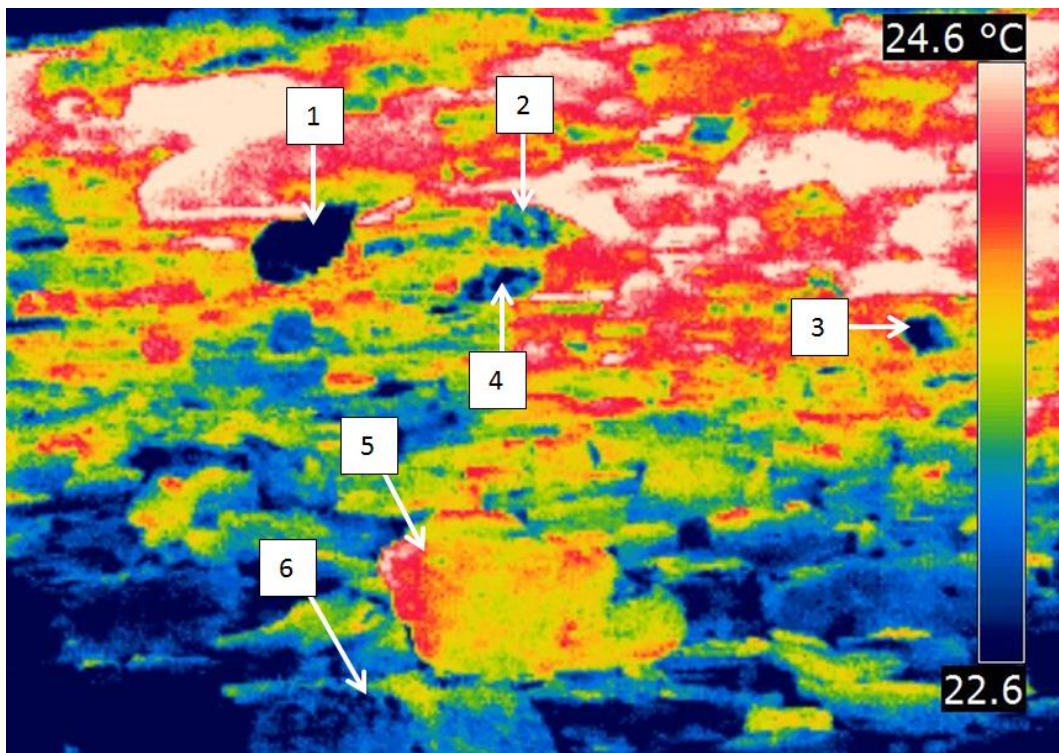
3m High Wall North facing wall in L'Espinass, France adjacent to that shown in Figure 7.14. Taken 10:45 07/09/13. Stones 1-4 show the effects of differing stone colour.

Being noticeably lighter and cooler than those around them. Stones 5&6 while appearing to be of similar size at the wall face stone 6 is cooler suggesting it potentially penetrates further into the wall and hence has better contact to the backfill. In this particular location it may also be an indication of differing material behind the wall as for the adjacent section.

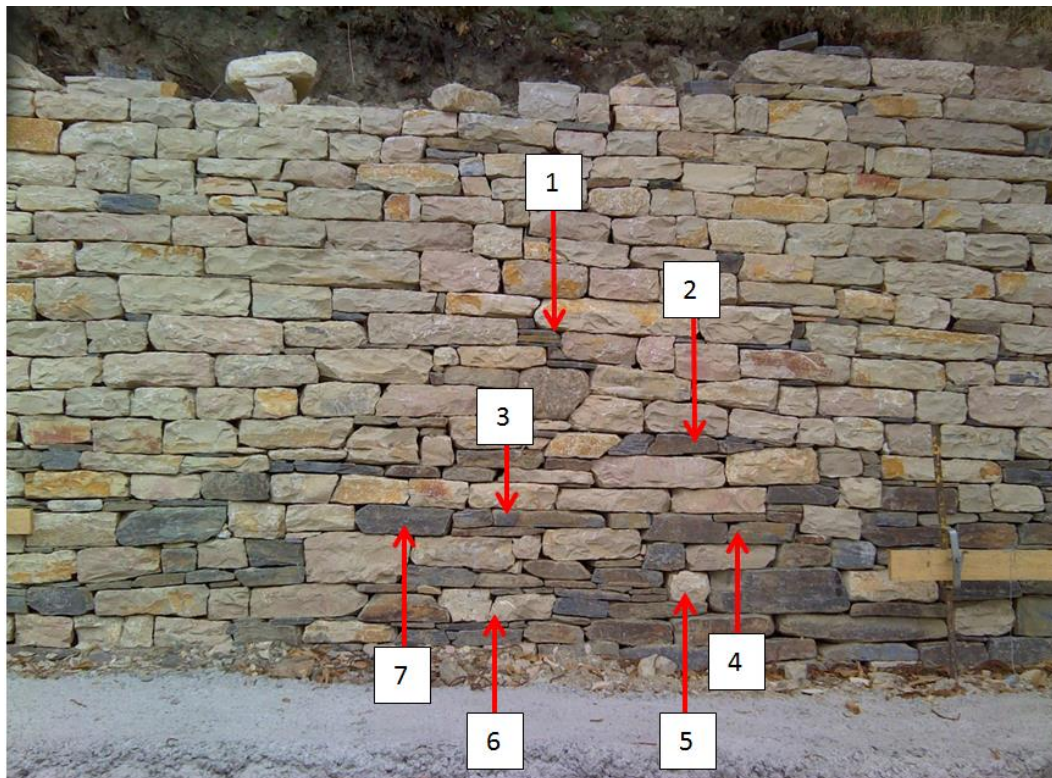
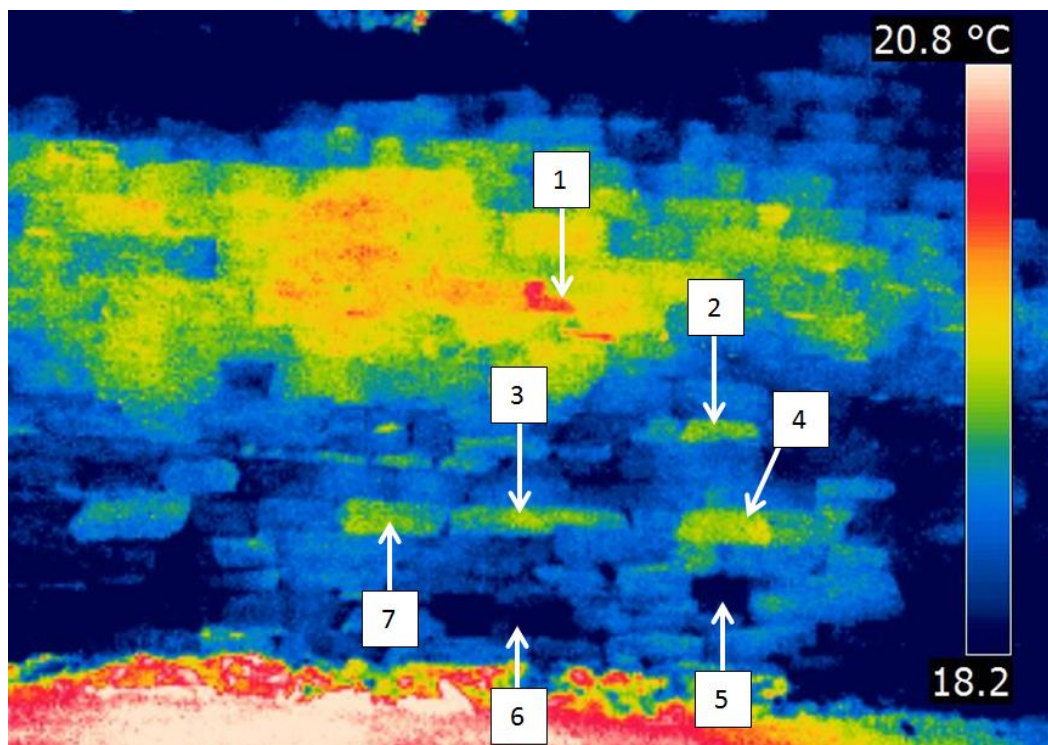
South Facing Wall in L'Espinas on the D35. Constructed using a variety of stone around a construction area. Construction was not completed at time of imaging and had not been fully backfilled. Highlighted stones show the effects of differing stone colours locally. Generally a warmer area of construction can be seen to the top of the wall, this is likely to correspond to an area where backfill has not yet been placed fully. And corresponds to the area of wall not yet completed that can be seen in the visual image.
